Good Connections

Information on Watertight Storm Sewers

Vol. 1 Issue 2

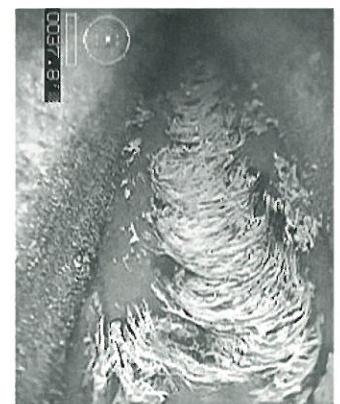
Gasoline can be seen mixing with water in the storm sewer.

During this inspection of the point where the gasoline had entered the system, a field tile was discovered. The field tile crossed under a gravel driveway within 10 feet of the fuel tanks

and their piping connections. Additional inspections found that the spill was isolated to that one path of migration through the tile. By using a CCTV camera, R & R was able to pinpoint the source of the infiltration and determine its cause: non-gasketed joints in the field tile. This serious situation created by gasoline infiltrating a drainage system could have had a worse outcome – much worse. It helps to demonstrate dramatically another important reason to design storm sewer and drainage systems that are watertight. In addition to point-source pollution as in this example, storm and drainage systems can serve to collect all forms of non-point-source pollution if these systems are not sealed properly. Non-gasketed or compromised pipe joints, pipe cracks at structure penetrations, and poorly sealed catch basins all serve to gather, transmit and disperse whatever fluids find their way into the system. Sealing the system gives control over what gets in, where it travels, and into what watershed it is deposited. The American Society of Civil Engineers (ASCE) states in its 2001 Report Card for America's Infrastructure that "Non-point-source pollution remains the most significant threat to water quality" under the drinking water section. (See inside cover for report details).

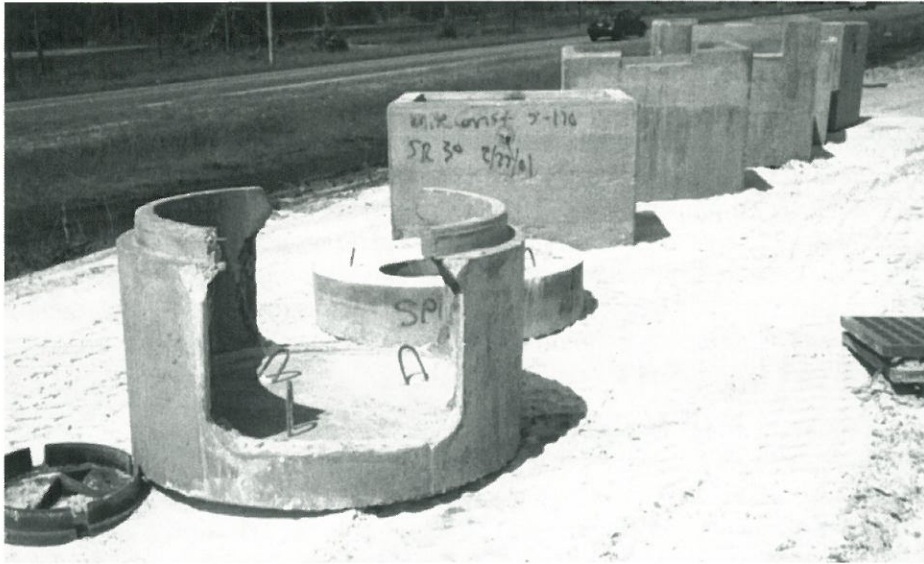
Manhole joints between adjoining risers and base sections have a no vacancy sign posted. Anytime we place a cutout, cored hole or opening within 6-inches of this mating surface, we may weaken both the structural integrity of the joint as well as its watertight capacity. The effect of physically entering into a joint with an opening of any type is easy to see.

The integrity of the sealing surface has been compromised, because it no longer exists. The structural continuity of the section has also been weakened since parts must now act as columns with minimum lateral support. Everyone can easily agree that this condition is undesirable and, in many jurisdictions, unacceptable.

The issue with the minimum distance relates to providing a section, which is not just a support, but an uncracked structural bridge over an opening. Any crack, no matter how minor, may result in a leak at the joint by providing water with a path around the gasket or through the wall.

A 6-inch joint clearance provides an adequate section to resist most vertical bearing loads and forces applied by pipe or expansion bands in any of the openings, cutouts or cored holes. This section also has a cross-sectional area sufficient in size to permit a detailed structural design with supplemental reinforcement, if necessary.

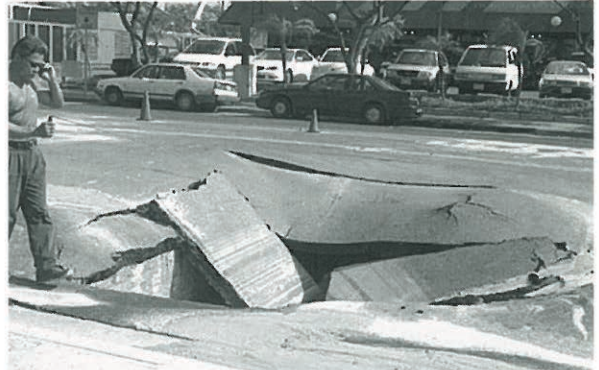
What a safety hazard! What do you think it will cost to repair this major intersection in Honolulu, Hawaii where a roadway collapsed around a storm drain?

Many potholes, subsidence, pavement distress and other road degradation around manhole covers, catch basins and curb inlets are caused by outdated and old-fashion methods using brick and mortar connections. Every issue we will publish a picture highlighting road damage associated with unsealed systems. If you have an interesting picture and we use it in our issue of Good Connections, you earn a \$100.00 reward. Please e-mail your pictures to joyce@frankgroupinc.com or mail to Frank Group, Inc., 2555 Kingston Road, Suite 230, York PA 17402. Please be sure to reference the Watertight Storm Sewer Group.
